## **Experience with De-icing systems, noise and vibrations evoked by ice accretion**

Dr. Daniel Brenner, [Daniel.Brenner@Weidmueller.com](mailto:Daniel.Brenner@Weidmueller.com)

Skellefteå, Winterwind conference, 08<sup>th</sup> Feb 2017

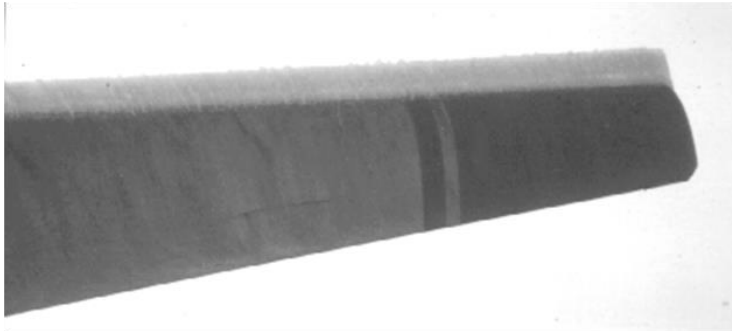
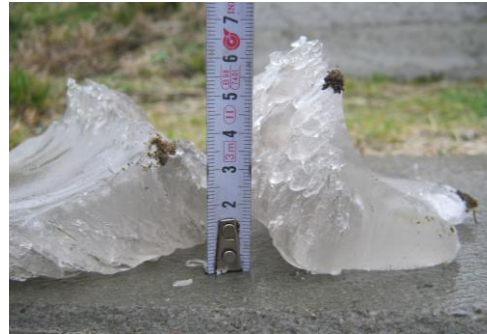
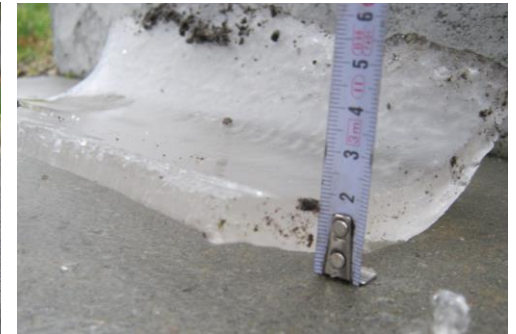
## Icing only on leading edge

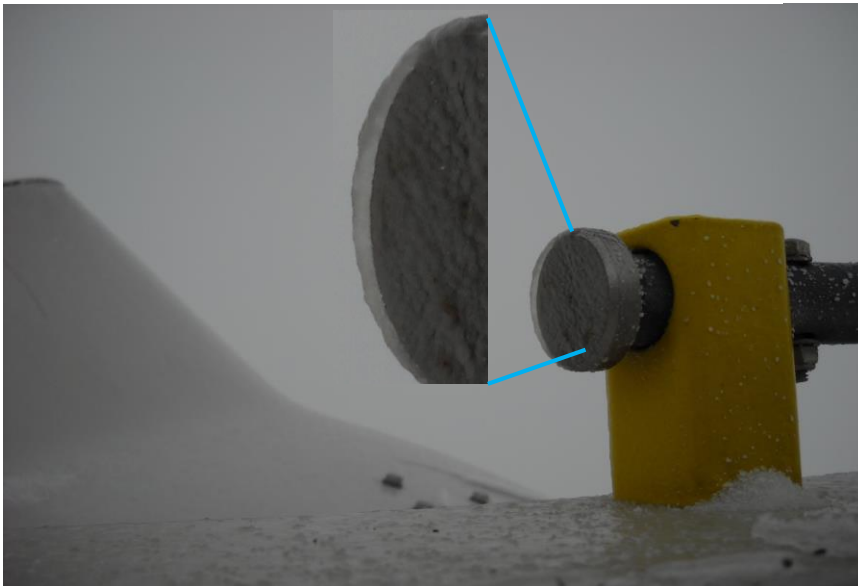
## Ice rain on whole turbine and blade

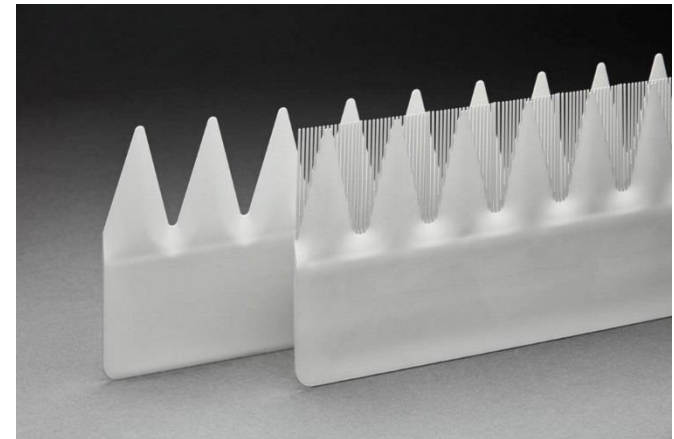
## Trailing edge icing esp. at serrations

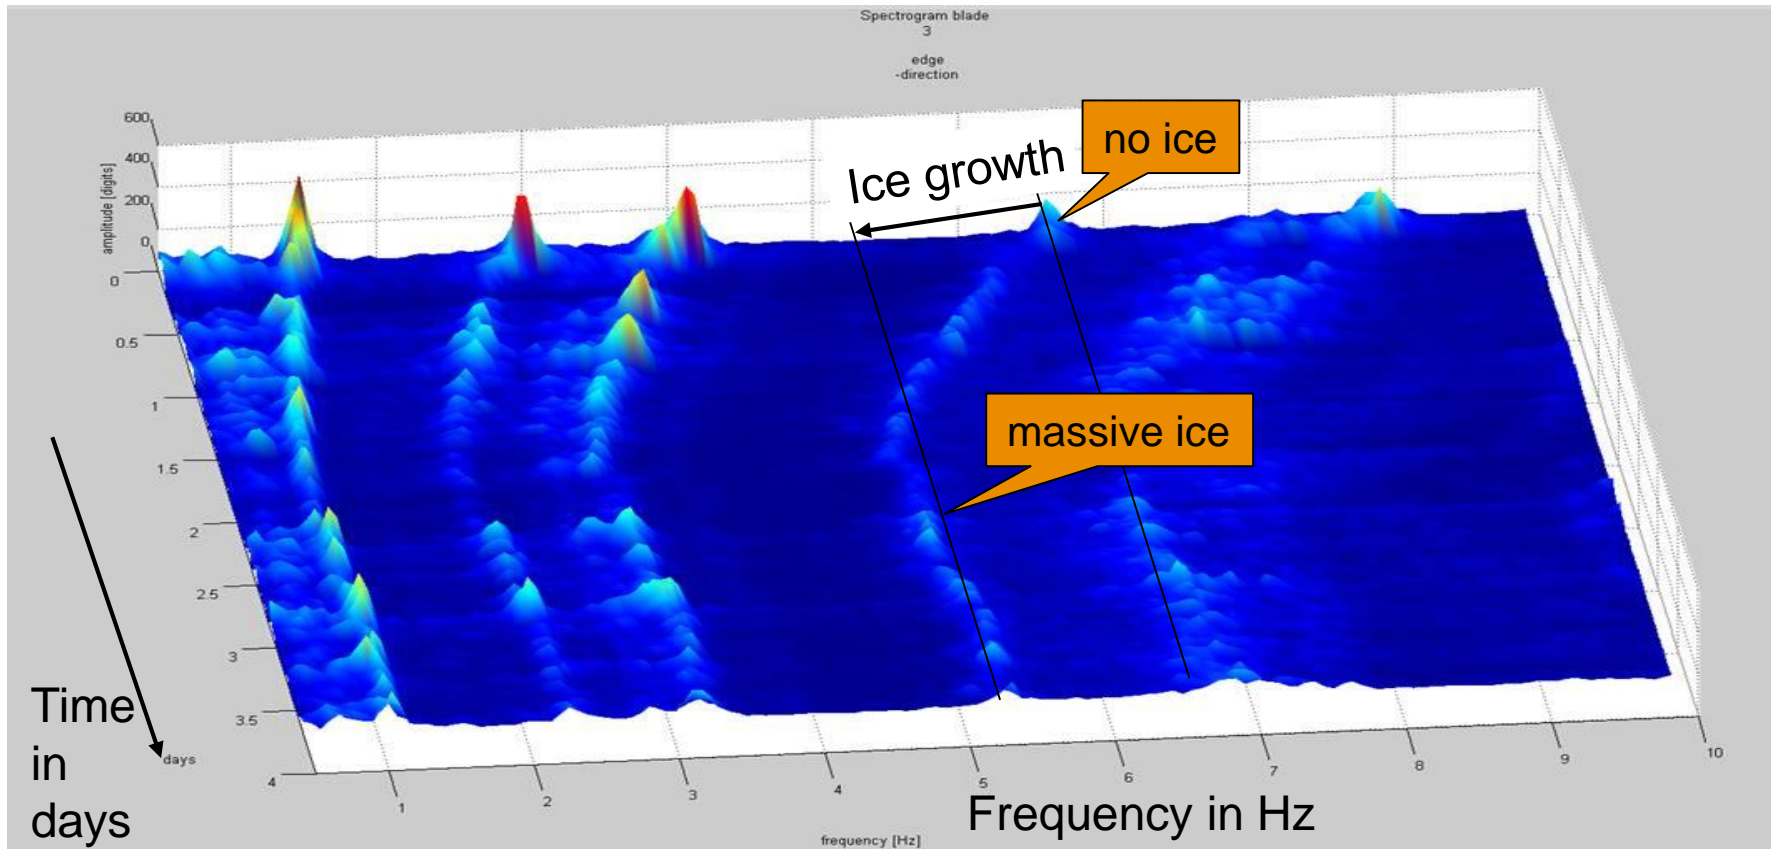
- All natural oscillations decrease due to ice
  - Blades natural frequencies as well as whole rotor natural frequencies

Icing event with over 250 kg ice per blade

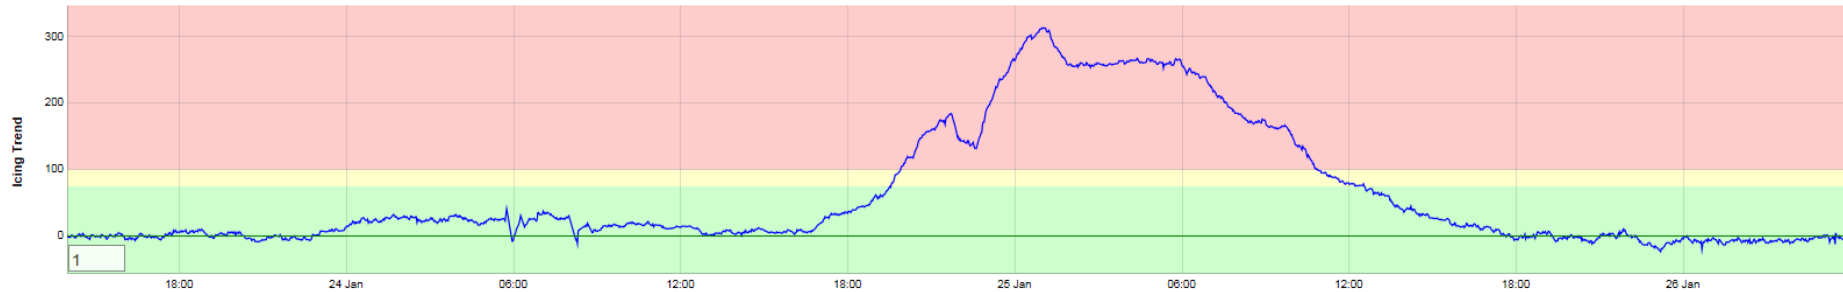
## Visualization of ice accretion over time

ice accretion plotted as blue line:

- Icing trend proportional to amount of ice
- Green area means „free of ice“
- Yellow – warning
- Red area – heavy ice accretion -> usually turbine stop necessary

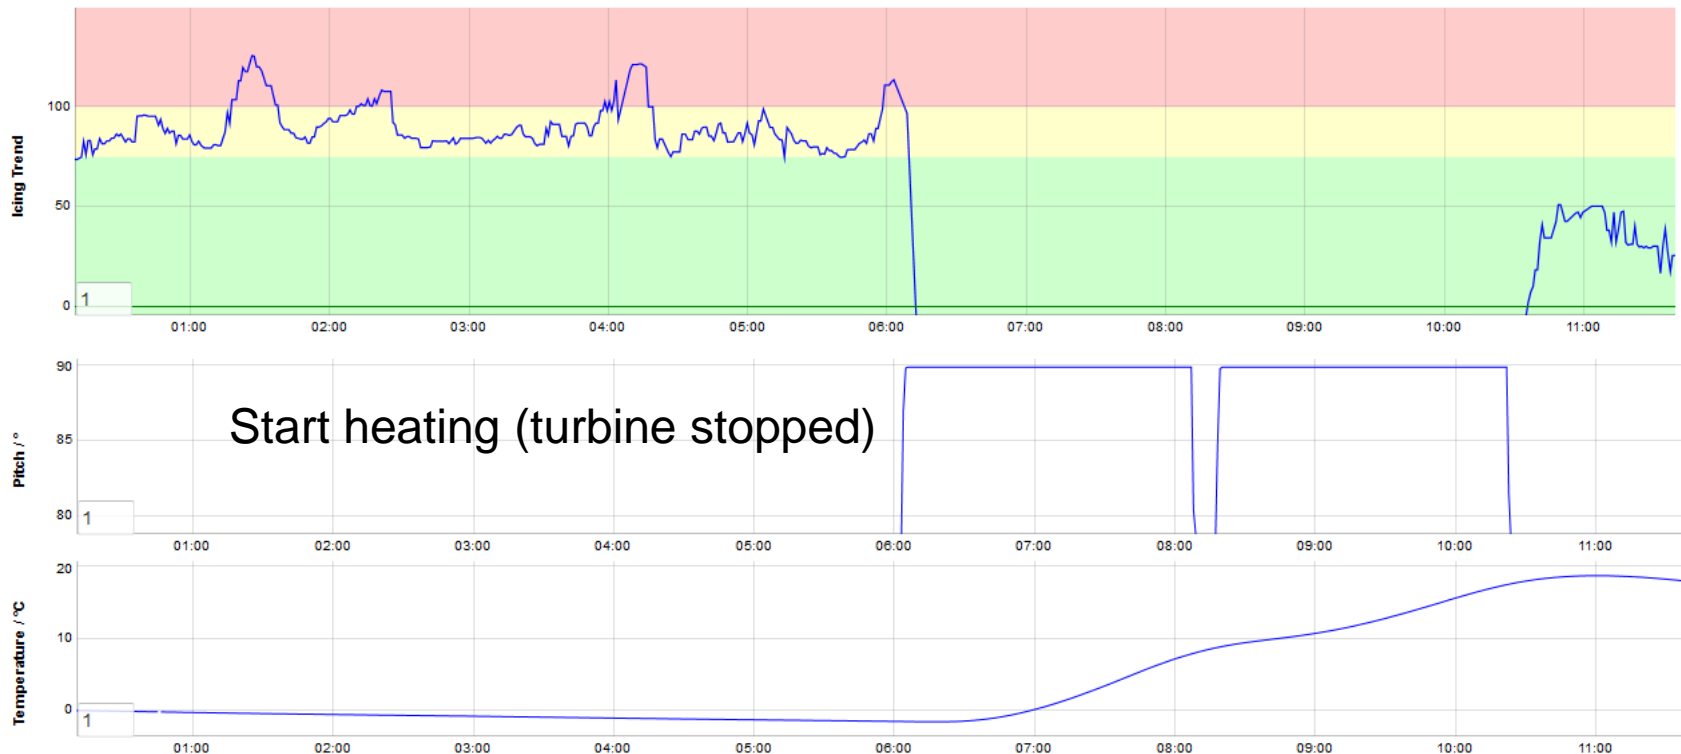
6 turbines with De-icing equipped with BLADEcontrol

Icing duration this season: 140 hours per turbine

Heating events this season: > 20 per turbine

**conclusion:** Hot air fan is a robust system / technique, capable of de-icing

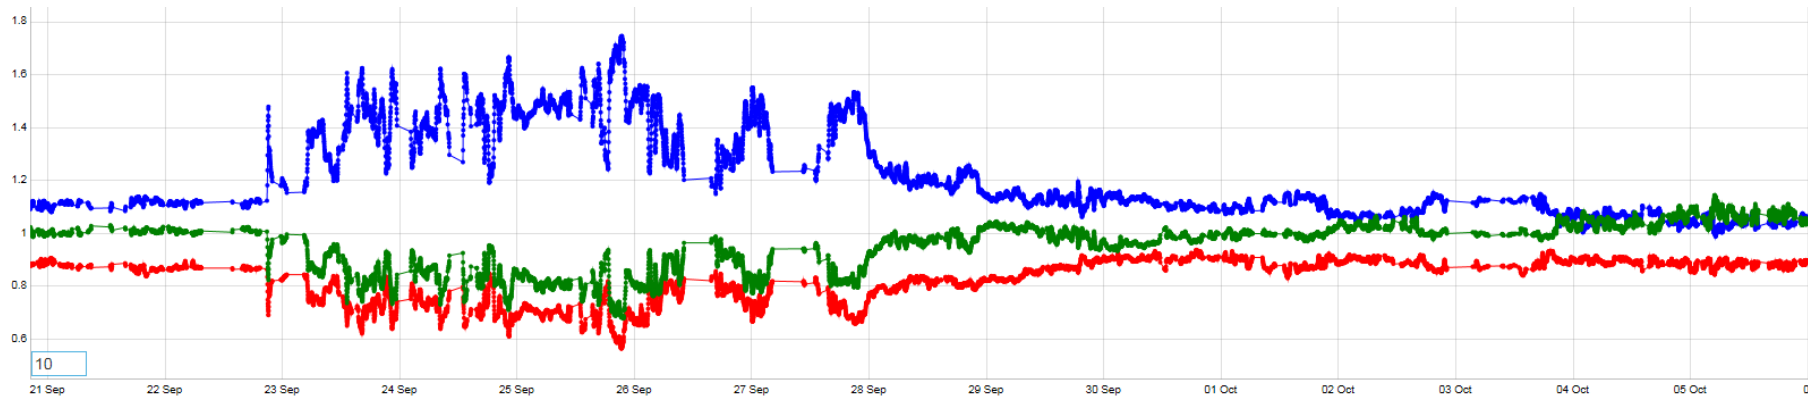
**Heating mat separated partly and was deinstalled before winter season**

**BLADEcontrol** damage detection indicator revealed defect at heating mat at blade 2 (blue)

**conclusion:** Proof of reliability for systems with heating mat on leading edge necessary

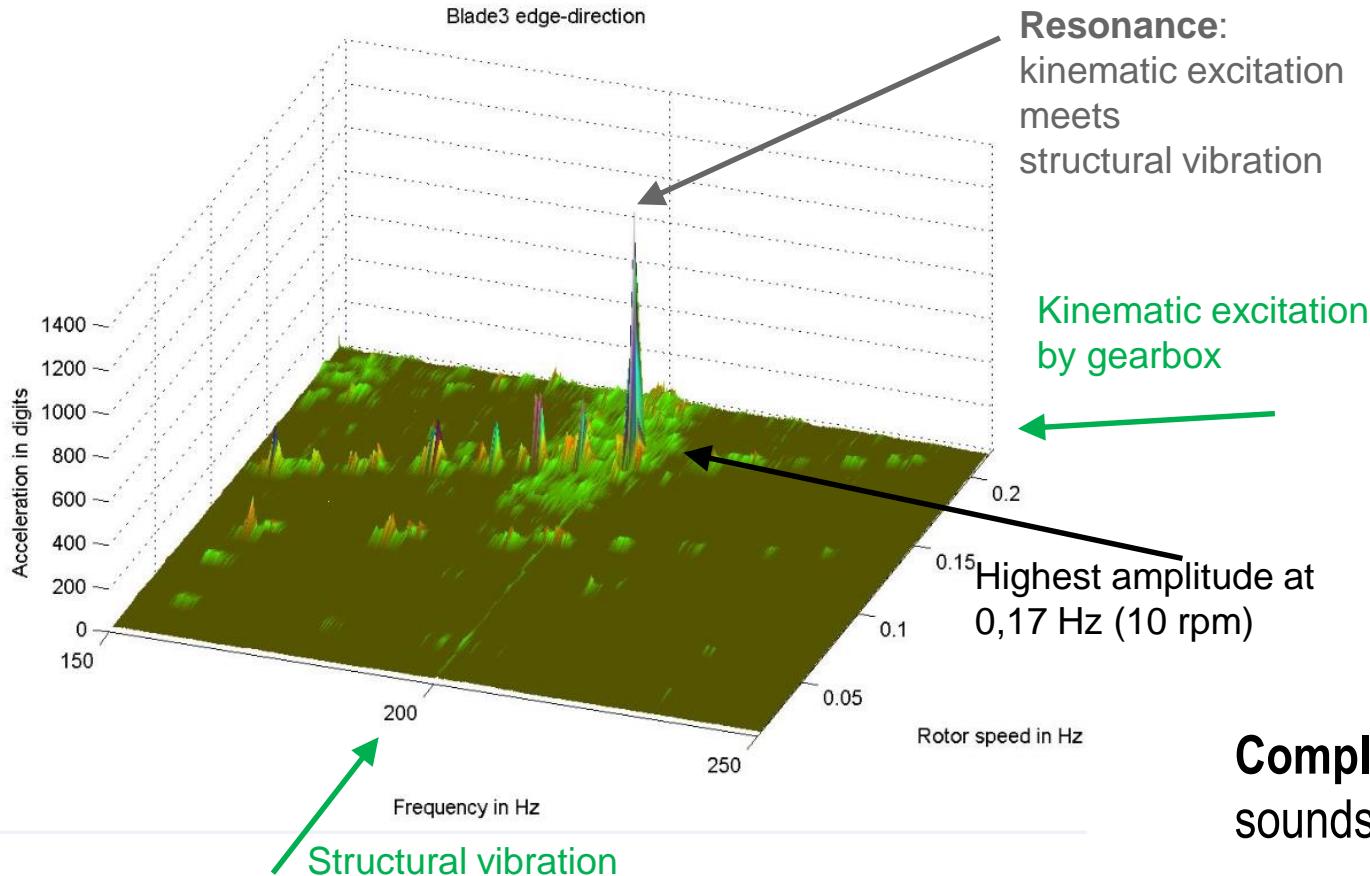
**Noise reduced mode**  
**Lower rotor speed** for  
 lower blade tip speed,  
 but **maximum torque**  
 for high power output

**For this Turbine**  
 Decreasing noise  
 strategy led to Tonality  
 -> increased noise

**Complaints by residents:**  
 sounds like a starting helicopter

**Influence of icing:** Reduction of vibration frequency shifts the tonality problem to a different rotor speed

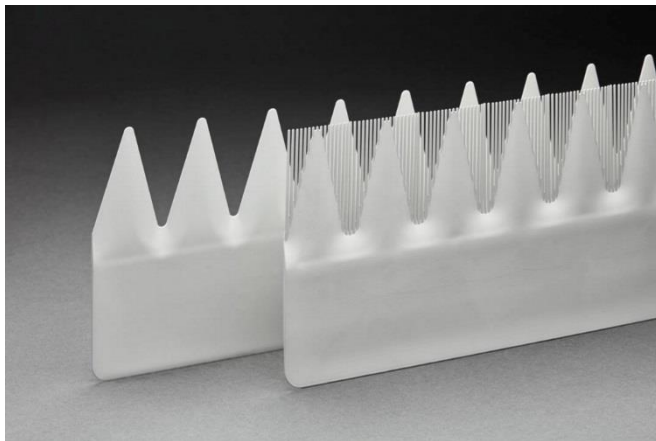
Complaints by residents near windfarms about whistling sound

Investigation by technicians on the turbine: very thin icing between teeth of serrations

Decreasing noise strategy led to whistling sound -> increased noise

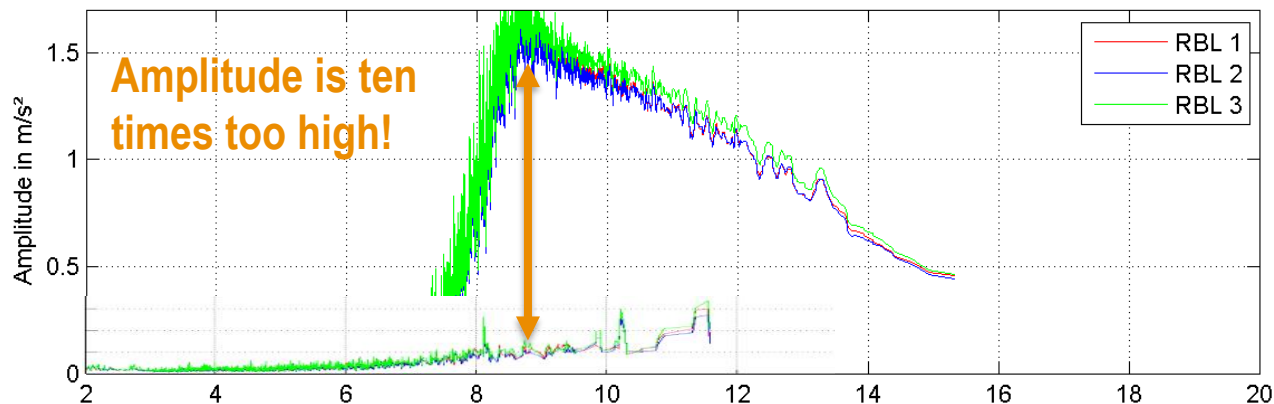
Amplitude of the drive train torsion vibration measured on the blades plotted over wind speed

Noticable measurement triggers information for manufacturer

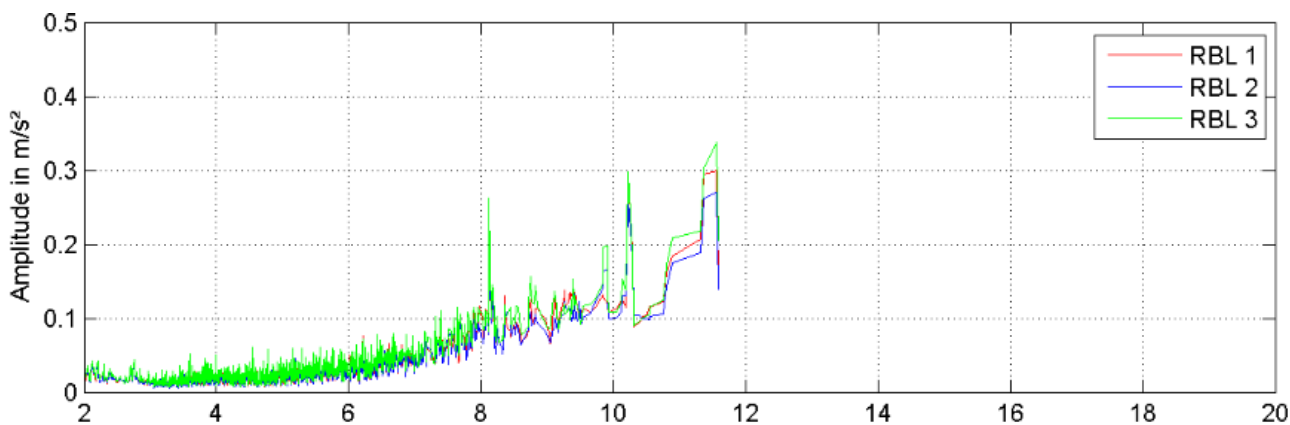
After correction by manufacturer

**Influence of icing:**  
Reduction of vibration may not be adjusted by open-loop controller

Reduction of the vibration via controller adaption

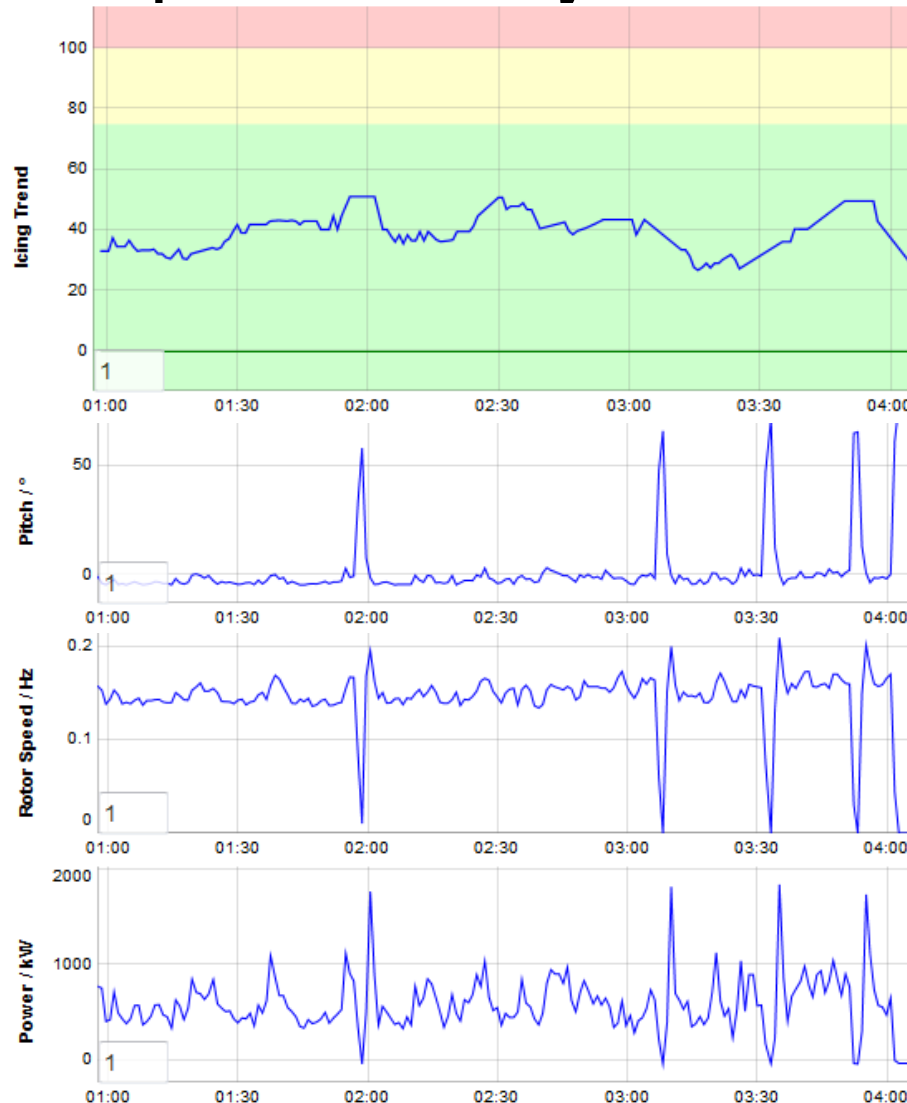
Only little icing, below 50 % of alarm value

Acceleration sensor in nacelle triggers turbine stop

height: 140m

1<sup>st</sup> natural tower vibration: 0.15 Hz

Rotor speed : 0.15 Hz (9 rpm)

Rotor speed = natural tower vibration

+ small imbalance

-> **RESONANCE**
