So where exactly is the ice – how many sensors does a turbine need?

Michael Moser | eologix sensor technology gmbh, Graz, Austria
Winterwind 2017 | 6. - 8.2.2017 | Skellefteå, Sweden

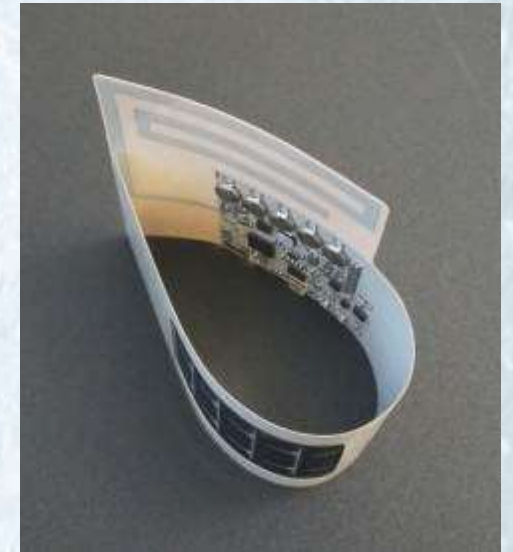
System Design

Sensors

- wireless
- flexible and thin (<2mm), adhesive
- ice detection on blade surface
- temperature measurement in each sensor

Base Station

- data collection and processing
- data output to turbine control
- raw data output to online system (web)
- location: nacelle or ground

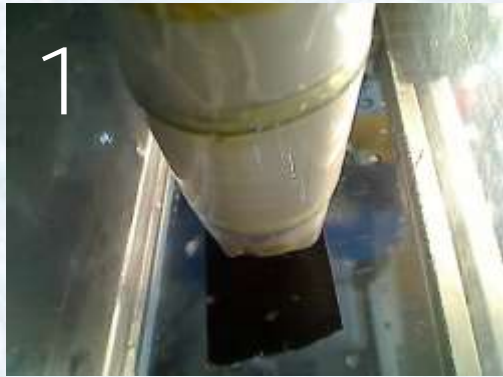
dry, free surface

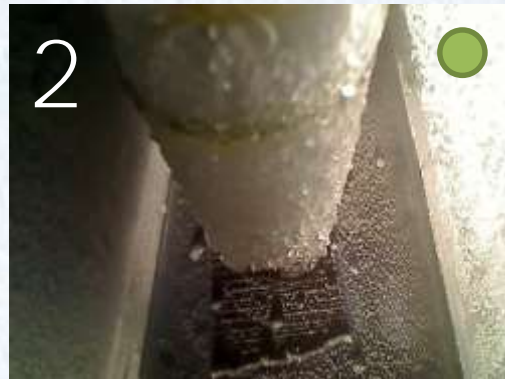
very thin layer
($< 1\text{mm}$) or wet

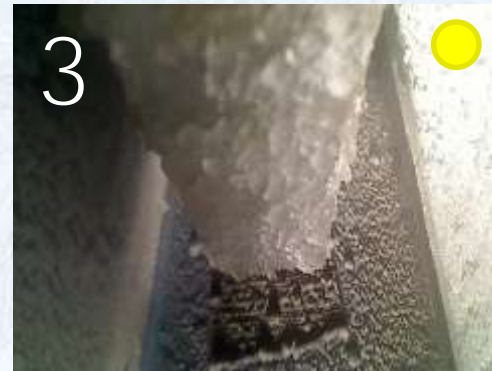
ice $> 1\text{-}2\text{mm}$

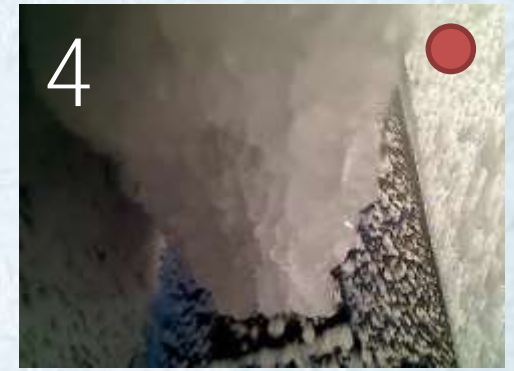
ice $> 10\text{mm}$

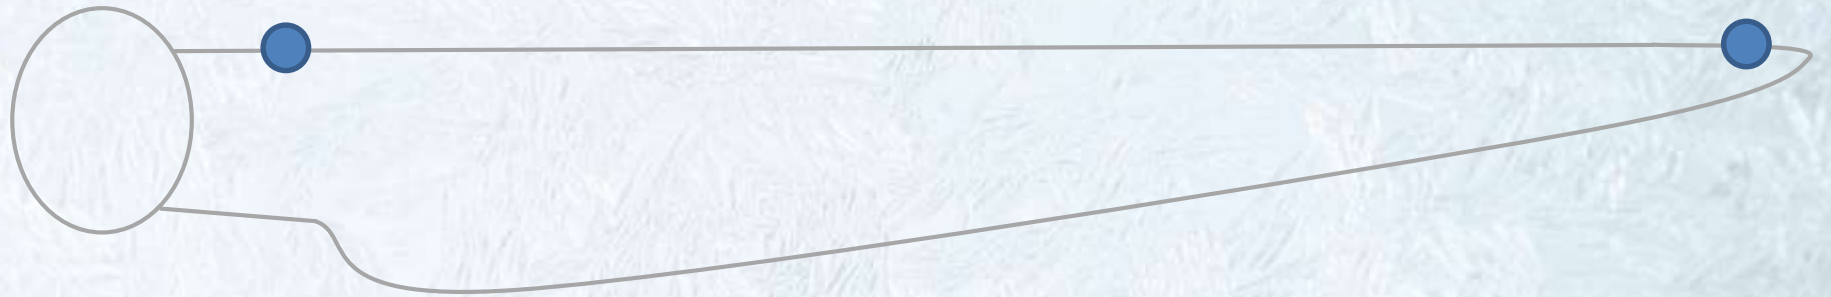
SAFE

- blade tips (>90%)
- blade root (<10%)
- total: 6 sensors
