# Combined effect of the heating and the superhydrophobic coating on the de-icing capability of the ultrasonic wind sensor

# Ultrasonic wind sensors

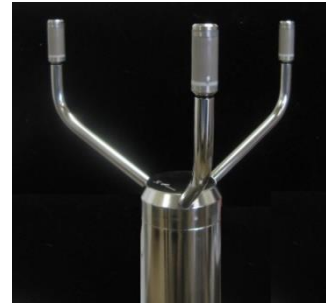
Model-I

Model-II

Model-III

Heated area

Extended heating area

Applying superhydrophobic coating

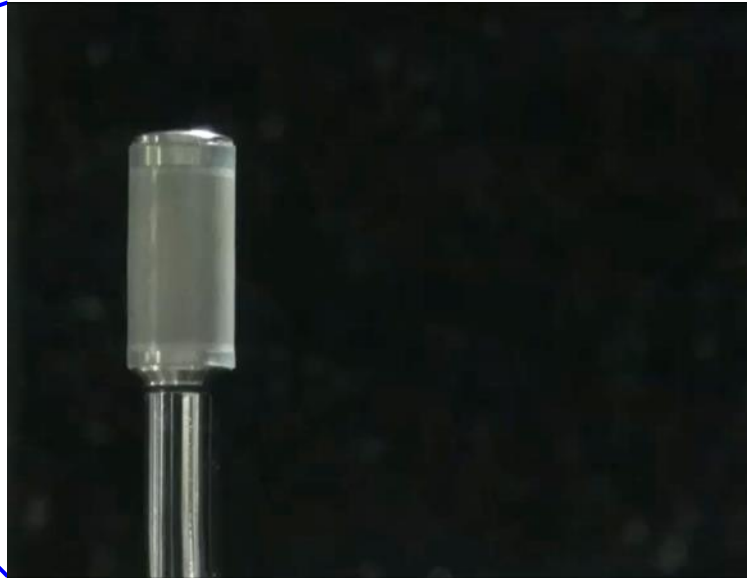
Model-II

Airspeed: 6 m/s

Ambient temp: -12 deg C

Snow flux: 3.74 g/m<sup>2</sup>s

- Snow melts and melt water runs downward on transducer surface

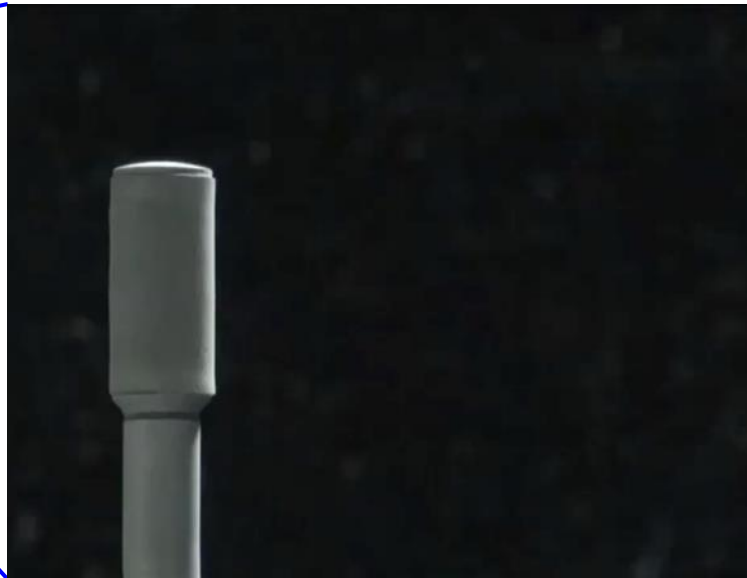
Model-III

- No snow/ice accretion occurs in the course of the test run
- Snow melts upon impact on the coated surface
- Some snow flakes are bouncing on the surface

- Verification of modifications by snowing wind tunnel test
  - Both modifications work well to prevent the sensor from icing and snow accumulation. In particular, coating achieves its water repellency.

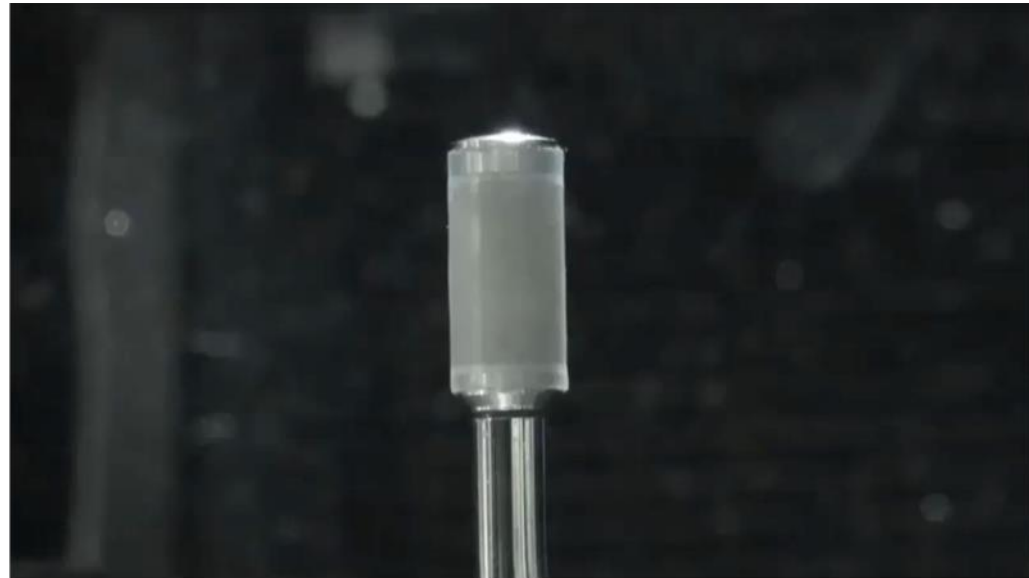
# Results of snowing test- at 1m/s

Snow flux:  
3.75 g/m<sup>2</sup>s

Model-II

Model-III

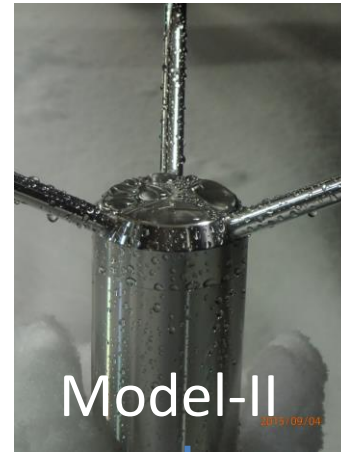
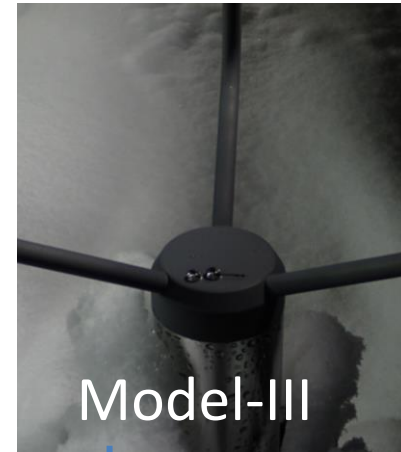
Preventing snow accumulation on the top cover by heating & heating+coating

Snow accumulation on the top cover and the lower arms of the previous model (no heated arms & top cover)

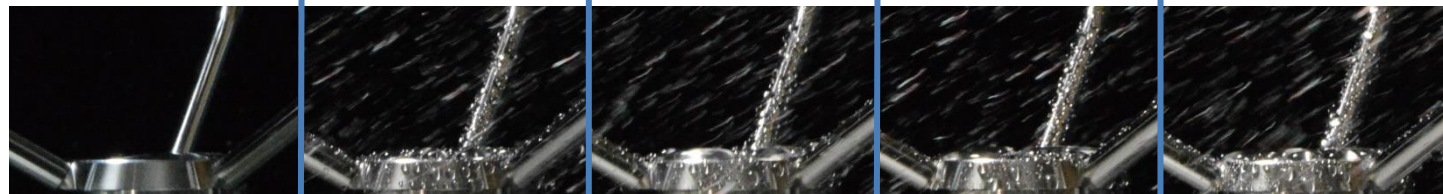
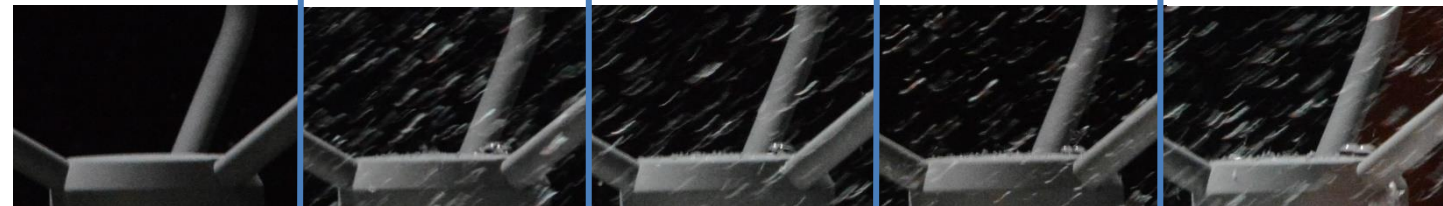
Model-II

Model-III

Snow flux: 3.75 g/m<sup>2</sup>s
